National Transportation Safety Board Aviation Accident Final Report

Location:	Newburgh, NY	Accident Number:	ERA15FA331
Date & Time:	08/28/2015, 1407 EDT	Registration:	N18FJ
Aircraft:	CORNELL W F/SAHAKIAN J A JR GILES 202 (G202)	Aircraft Damage:	Destroyed
Defining Event:	Aircraft structural failure	Injuries:	1 Fatal
Flight Conducted Under:	Part 91: General Aviation - Air Race/Show

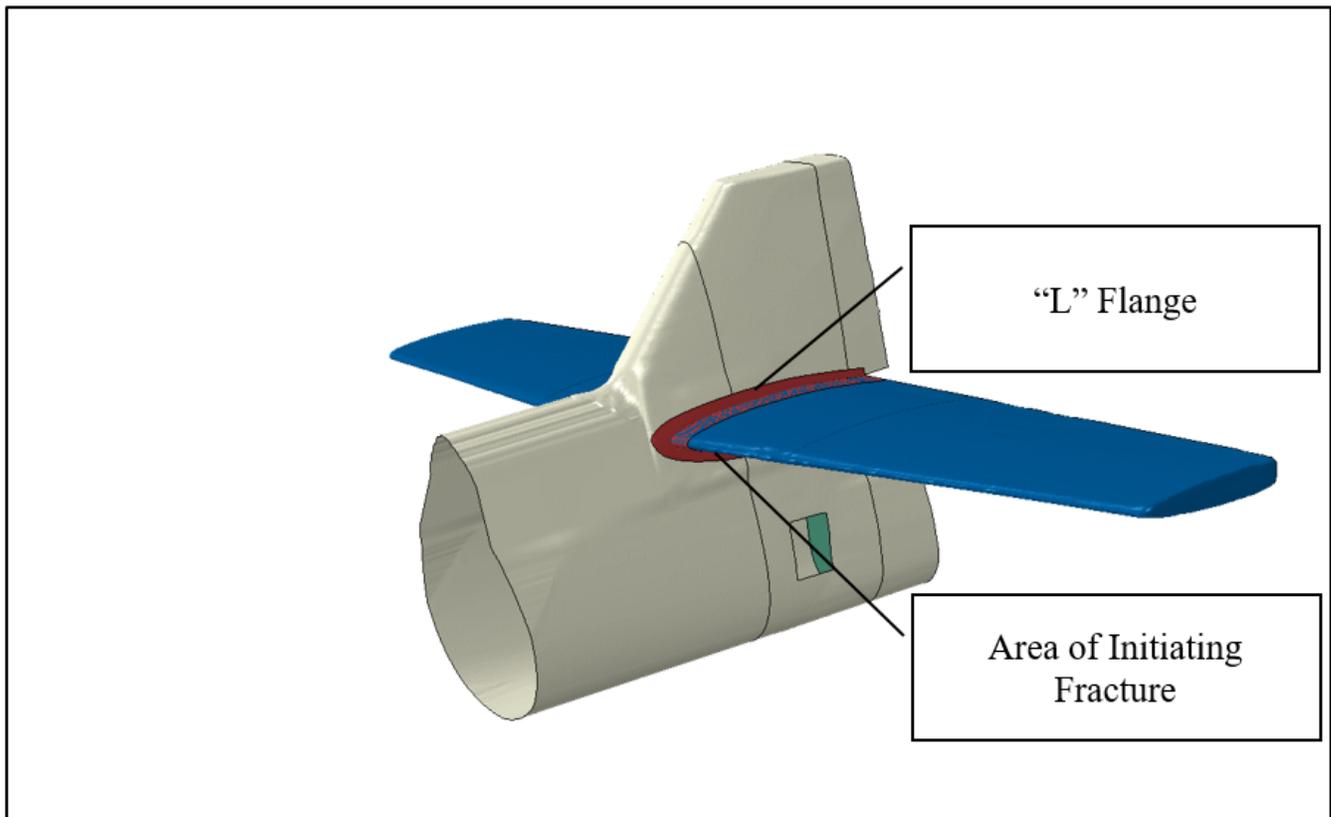
Figure 1 - Horizontal and Vertical Stabilizer Joint

Follow-up examinations of the airframe revealed that the horizontal and vertical stabilizer had fractured from the remainder of the airplane in several locations: along the lower side of the horizontal stabilizer at the bonds between the skin panels and the "L" shaped flanges attaching the lower side of the horizontal stabilizer to the vertical stabilizer and fuselage skin panels, at the bond between the upper end of the banjo bulkhead and the lower skin of the horizontal stabilizer, through the fuselage skin forward of the vertical stabilizer, and through the vertical spar at the aft end of the vertical stabilizer (See Figure 1).

were constructed of glass-fiber-reinforced cloth and epoxy, were fractured from their mating surfaces on both legs of the "L" (the legs mating to the lower horizontal stabilizer skin and to the fuselage skin) in several locations. The bond between the banjo bulkhead and the horizontal stabilizer lower skin was fractured entirely. Most of the bond surface area in all locations exhibited evidence of fiber pullout and resin transfer; however, two areas that showed limited fiber or resin transfer were located on the left flange where it had mated to the lower skin of the horizontal stabilizer near its leading edge.

A study examining all the fractures in the tail area determined that the first fracture to occur was the bond fracture in the left flange at the bottom of the horizontal stabilizer near its leading edge. The fracture features in this area were consistent with tensile opening, which translates to a relative upward motion of the left side of the horizontal stabilizer (or, relative downward motion of the lower fuselage skin on the left side of the tail). There was no clear evidence of progressive crack growth on any of the fracture surfaces. Some contact damage on the fracture surface was present.
