AkroTech Aviation, Inc.	
		Service Bulletin Summary	
S.B. #	Model	Part	Date Released
3.D. #	G-200	Aileron Bellcranks	
2	G-202	Rear Spar Carrythrough Bulkhead	
3	G-202	Elevator Nose Rib	
4	G-200	Landing Gear Mounting Structure	
5A	G-202	Landing Gear Mounting Structure	
5B	G-202	Landing Gear Mounting Structure	
6	G-200	Rear Wing Spar Carrythrough	
7	G-202	Rear Wing Spar Carrythrough	
0.50	G-202	Rear Wing Spar	
8A	G-200	Rear Wing Spar	
8B	G-202	Rear Wing Spar	
9	G-202	Fuel Tank	
10		Rudder Pedal Carriage Plate	
11	G-200 G-202	Swing Tube Mount Phenolic	
12		Engine Mount Bolt	
14	G-202/G-200	Rucker Jug	
15	6-202	1 al milets	
16	AII	WERT STAB SKIN CUTTING	
17	All	VERT, STAB SKIN CUTTING	
18		I and Many & Curmett	1/4/00
19	All	SEALING/REINFORCING HARES & CUTIVITS	.,
20

AkroTech Service Bulletin #1

AkroTech Service Bulletin #2

AkroTech Service Bulletin #3

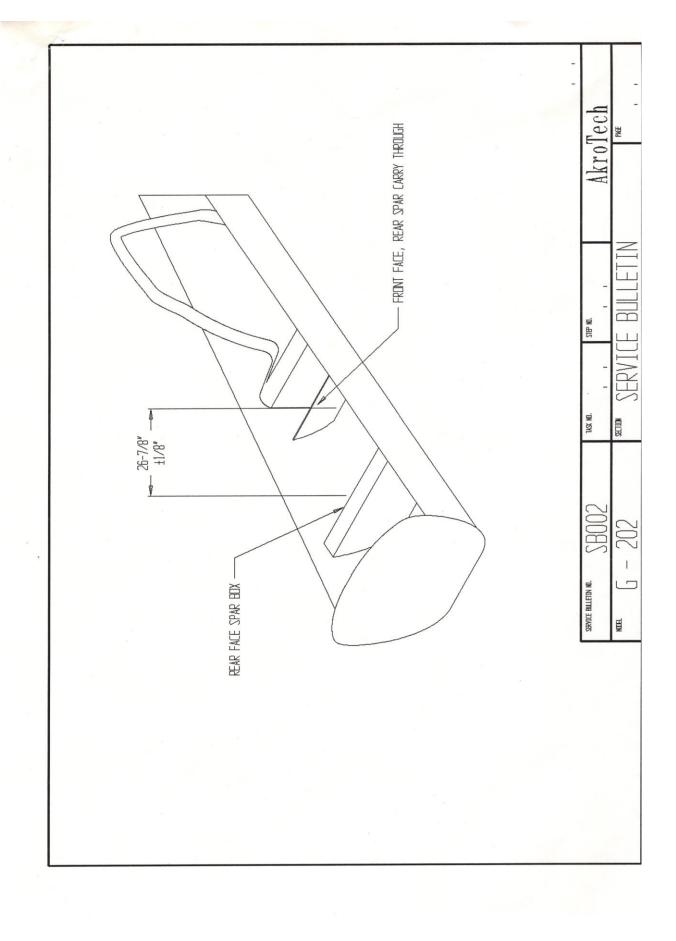
Bulletin: Owners of G-202 kits with serial numbers between 003 and 006 are asked to verify the dimension between the rear face of the spar box to the forward face of the rear spar carry through. The straight line distance between the box and bulkhead should be 26 7/8 inches with an allowable tolerance of plus or minus 1/8 inch. Both of these components are installed in the lower fuselage in the production of E-Z build kits. A review of jigging techniques used in assembly has revealed that installation may not be within tolerances.

If installation is not within tolerances, please contact AkroTech Aviation. Removal and replacement of the rear spar carry through will be conducted by AkroTech at the owner's site for all cases involving misinstallation.

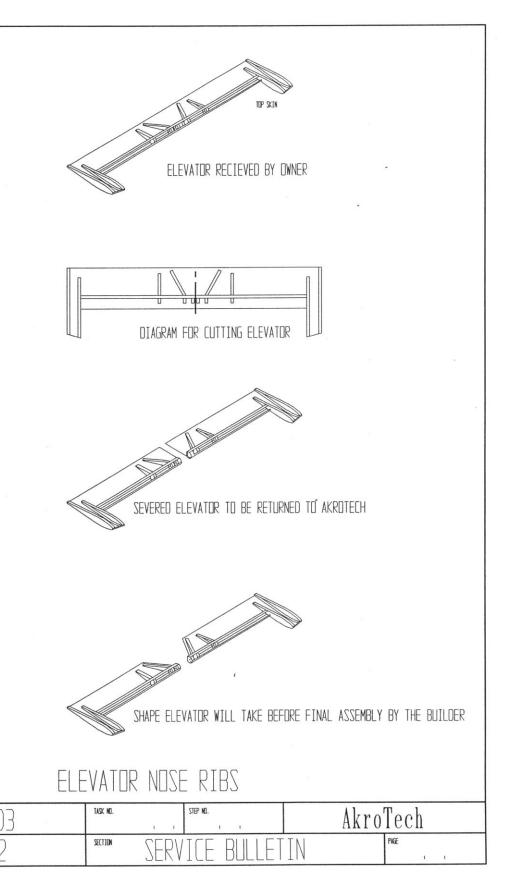
Bulletin: Owners of G-202 kits with serial numbers between 002 and 007 are in receipt of elevators assembled using nose ribs with a radius oversized by 1/8 inch. This can cause difficulty in joining the top elevator skin to the bottom skin at the leading edge. The oversized ribs should be removed and replaced with nose ribs of the proper radius.

AkroTech Aviation will remove the oversized nose ribs and install the proper radius nose ribs at our facility in Scappoose, Oregon. Owners are asked to ship the elevator skin that has the spar and ribs attached to AkroTech. Arrangements for covering the cost of shipping can be made by contacting Alisha Hamel at AkroTech.

For ease of shipping, owners are asked to cut the elevator at the midpoint. The attached drawings depict the rudder as received by the owner, the diagram for cutting the elevator, the severed elevator to be returned to AkroTech and the shape the elevator will take before final assembly by the builder.

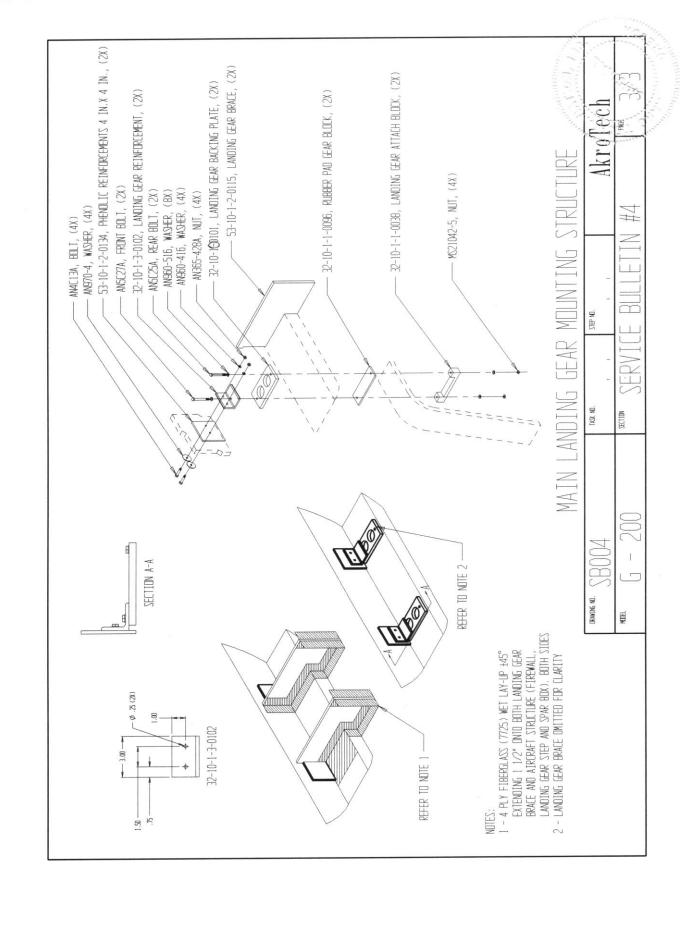
G-200 aircraft with the serial numbers listed above need to have the main landing gear mounting structure modified as specified in this service bulletin.

With the landing gear installed, locate the two landing gear braces (P/N 53-10-1-2-0115) ¼" inboard of the landing gear backing plates (P/N 32-10-1-1-0101). Mark these locations. Locate the phenolic blocks (P/N 53-10-1-2-0134) on the firewall directly ahead of the backing plates. Position the landing gear reinforcement angles (P/N 32-10-1-3-0102) as shown. Determine the location of the hole through the bottom of the gear reinforcement angle. The hole must be sufficiently far from the corner of the reinforcement angle to allow the head of the bolt to rest entirely on the flat surface of the angle as on Section A-A. If necessary, reduce the thickness of the phenolic reinforcement by sanding to a minimum of 3/16" for bolt head clearance.

Hold the phenolic reinforcement and gear reinforcement angle firmly in place. Using the attach block, existing hole, and backing plate for alignment, drill a 5/16" hole up through the gear reinforcement angle. Mark the location of the phenolic reinforcements on the firewall. Remove the bulkheads, backing plates, gear reinforcements, and phenolic reinforcements.

Prepare the fuselage, firewall, landing gear braces, and phenolic reinforcements for bonding by sanding thoroughly with 80 grit sandpaper then cleaning thoroughly with acetone. Bond the braces and phenolic reinforcements in place using Hysol. Allow the Hysol to cure.

Add a four layer wet layup fiberglass flange at the indicated areas. This flange should extend 1.5" onto the braces and 1.5" onto the fuselage and should completely cover the landing gear backing plate area. Allow to cure completely.

Drill the upper mounting holes in the landing gear reinforcement angles as shown. Reinstall the landing gear, gear attach blocks, backing plates, and gear reinforcement angles, including the 32-10-1-1-096 rubber pads. Drill two ¼" holes through the firewall at each gear reinforcement angle using the previously drilled holes as drill guides. Install the bolts through the firewall as shown.

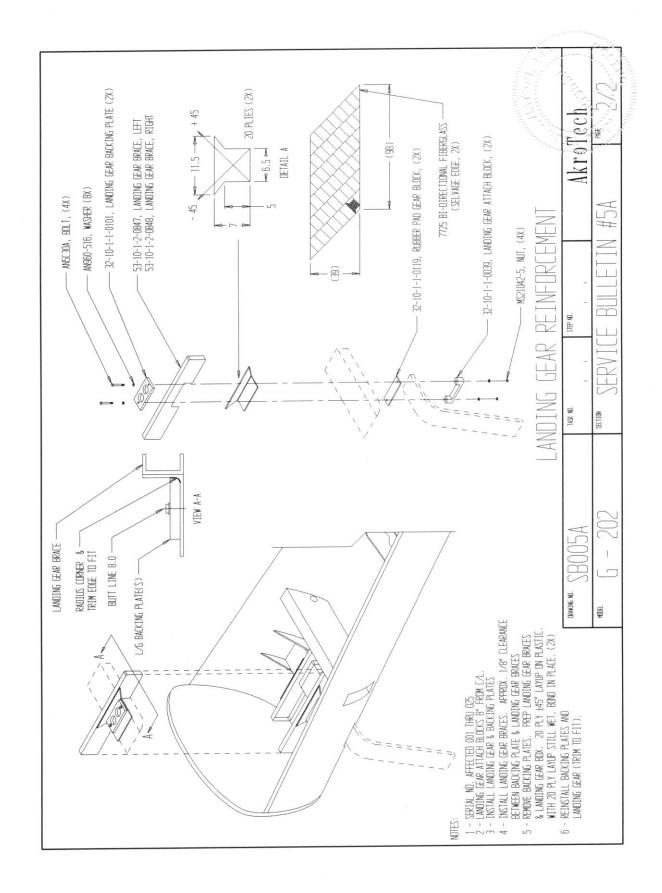
G-202 aircraft with the serial numbers listed above need to have the main landing gear mounting structure modified as specified in this service bulletin.

The correct layup schedule for the fiberglass pads is 20 plies of fiberglass with $\pm 45^{\circ}$ fiber orientation. Additionally, the layup template was not included in the manual. Correct size for this layup is specified in the attached drawing.

Step E Layup 2 fiberglass reinforcements as shown in Detail A on plastic. Paint the prepared areas with resin. Place each reinforcement on its designated area, remove the plastic and carefully work out all air from under the layup. Allow to cure completely.

If the landing gear braces, P/N 53-10-1-2-0847/0848, and fiberglass pad have been installed as per Task F-21 an additional 10 layers will need to be added at this time. Remove the main landing gear if installed. Prepare the indicated areas for bonding by sanding thoroughly with 80 grit sandpaper then cleaning with acetone. Layup 2 fiberglass reinforcements 10 plies thick, with the same dimensions as shown in Detail A on plastic. Paint the prepared area with resin. Place each reinforcement on its designated area, remove the plastic and carefully work out all air from under the layup. Allow to cure completely.

Trim the landing gear backing plates as shown, minimum as required. Two rubber pads, P/N 32-10-1-10119, will be installed between the landing gear and gear step as shown on the attached drawing. Longer landing gear mounting bolts have been provided to accommodate the thickness of these pads. Reinstall the main landing gear.

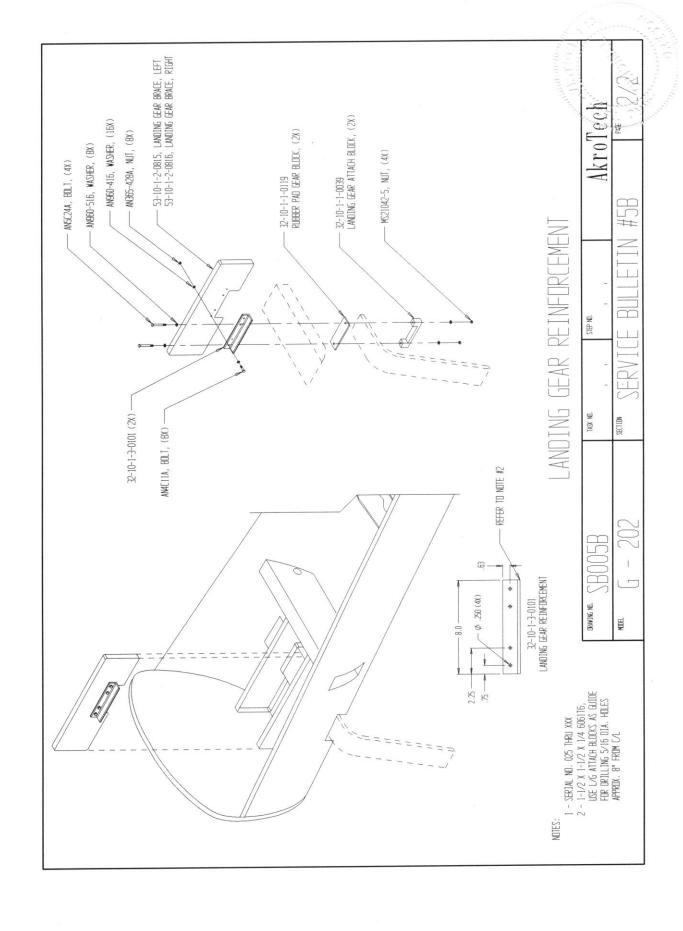
G-202 aircraft with the serial numbers listed above need to have the main landing gear mounting structure modified as specified in this service bulletin.

Fabricate two P/N 32-10-1-3-0101 as shown in Note #2. Use the landing gear attach blocks, P/N 32-10-1-1-0039, as a drill guide to drill the two landing gear mounting bolt holes through each landing gear reinforcement. Install the landing gear attach blocks, landing gear, rubber pads, and landing gear reinforcements as shown. Omit Step F. Complete Step G.

Complete TASK F-21 through Step C using the installed reinforcements to locate the landing gear braces. Do not bond these braces to the reinforcemts. After the bulkhead is bonded in place match drill the four holes through the bulkheads and install the specified hardware

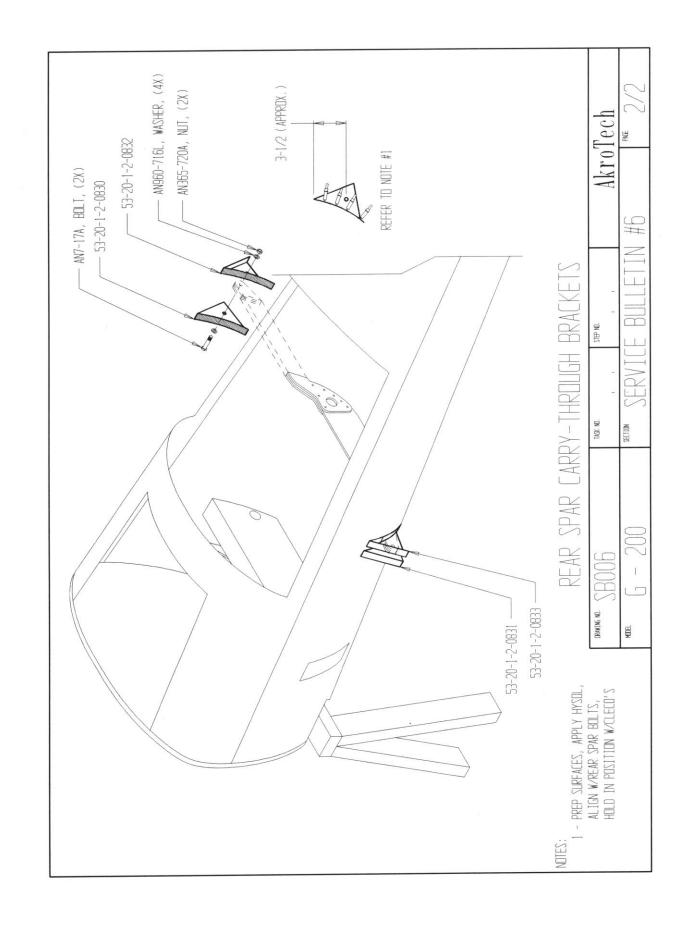
G-200 aircraft with the serial numbers listed above need to have the rear wing spar carrythrough structure modified as specified in this service bulletin. Compliance with this service bulletin should be accomplished before further flight.

The aircraft will need to have the rear spar attach plates already attached, as per assembly manual task F-17. Remove the wings from the aircraft, if installed. Test fit the brackets as shown in the attached drawing. Each of the four brackets is different - make sure they are fit in the correct position. Mark each bracket's location on the fuselage. While holding the brackets in position drill several cleco holes through the fuselage and brackets. Cleco in place. Use a transfer punch to locate the center of the rear spar bolt hole in each bracket, one at a time. Remove the bracket and drill a 1/8" pilot hole at this position. Use a step drill or drill bits in 1/8" increments to carefully size the hole up to 7/16". Repeat for each of the four brackets.

Prepare the areas marked on the fuselage and four brackets for bonding by sanding thoroughly with 80 grit sandpaper then cleaning with acetone. Bond the brackets to the fuselage using Hysol. Hold in position during cure by inserting the rear spar attach bolt through the brackets and the rear spar plates. Finger tighten a nut onto the bolt to clamp the brackets against the backing plates. DO NOT BOND THE BRACKETS TO THE ALUMINUM REAR SPAR PLATES ONLY TO THE FUSELAGE! Allow to cure then remove cleaces and bolt.

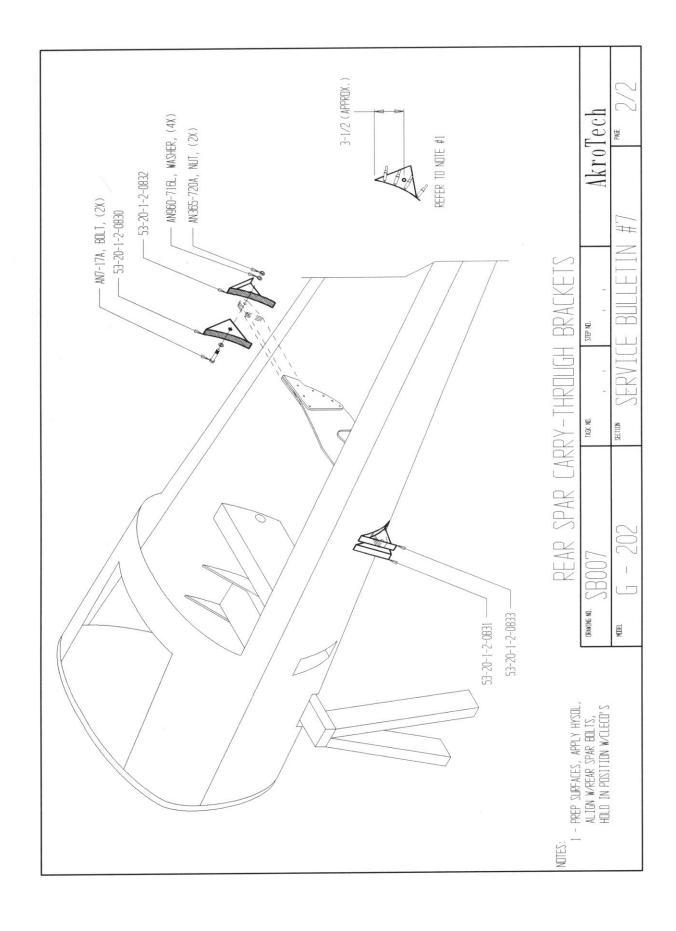
G-202 aircraft with the serial numbers listed above need to have the rear wing spar carrythrough structure modified as specified in this service bulletin. Compliance with this service bulletin should be accomplished before further flight.

The aircraft will need to have the rear spar attach plates already attached, as per assembly manual task F-19. Remove the wings from the aircraft, if installed. Test fit the brackets as shown in the attached drawing. Each of the brackets is different - make sure they are fit in the correct position. Mark each bracket's location on the fuselage. While holding the brackets in position drill several cleco holes through the fuselage and brackets. Cleco in place. Use a transfer punch to locate the center of the rear spar bolt hole in each bracket, one at a time. Remove the bracket and drill a 1/8" pilot hole at this position. Use a step drill or drill bits in 1/8" increments to carefully size the hole up to 7/16". Repeat for each of the four brackets.

Prepare the areas marked on the fuselage and four brackets for bonding by sanding thoroughly with 80 grit sandpaper then cleaning with acetone. Bond the brackets to the fuselage using Hysol. Hold in position during cure by inserting the rear spar attach bolt through the brackets and the rear spar plates. Finger tighten a nut onto the bolt to clamp the brackets against the backing plates. DO NOT BOND THE BRACKETS TO THE ALUMINUM REAR SPAR PLATES ONLY TO THE FUSELAGE! Allow to cure then remove cleaces and bolt.

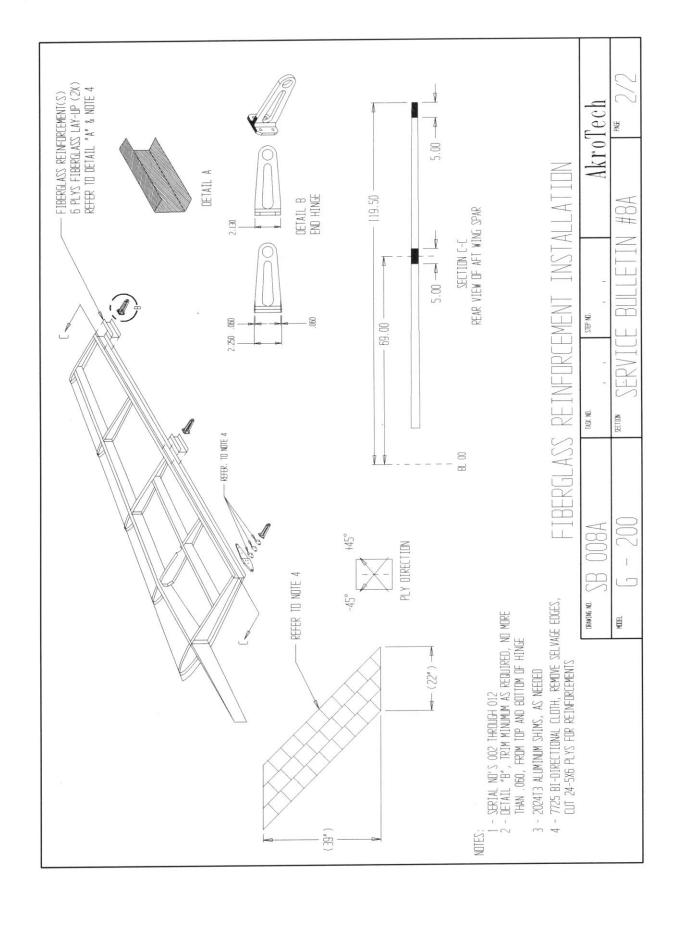
G-200 aircraft with the serial numbers listed above need to have the rear wing spars reinforced as specified in this service bulletin. Compliance with this service bulletin should be accomplished before further flight. Compliance with this service bulletin can be accomplished before or after the wings have been closed.

Remove aileron hinges from the wings. Prepare the rear spars for bonding at the areas indicated in the attached drawing by cleaning with acetone, sanding thoroughly with 80 grit sandpaper, and recleaning with acetone. Carefully fill the aileron hinge mounting holes with a bright color of modeling clay.

Layup six plies of fiberglass with a ± 45 degree fiber orientation on plastic. This layup should be large enough to make four reinforcements, totaling approximately 15" x 15". Cut out the four reinforcements, approximately 5" x 6"each, from this piece. Paint the prepared areas on the rear spar with laminating resin.

Place a reinforcement on the rear spar in its designated area, carefully working out all air from under the layup and maintaining the fiber orientation at ± 45 degrees to the spar. Use a fine point pick to push the fibers aside around each aileron hinge mounting hole. Again remove any air from under the layup. Clear tape several paint sticks and use spring clamps to hold the layups against the top and bottom rear spar flanges. This will help hold the lay-ups tight against the rear spar face. Repeat the process for each of the indicated areas. Inspect the reinforcements to assure that they are wrinkle free and there is no air under the layup.

After the layups have cured, trim them flush with the trailing edge of the wing. Clear any remaining fibers from the aileron hinge mounting holes using a 1/4 inch drill bit. Use caution that the drill bit does not go so far into the hole as to damage the nutplate!!

Measure the thickness of the reinforcements at the trailing edge of the wing. Fabricate shims to go under the inboard hinge equal to the reinforcement thickness. Measure the distance between the rear spar flanges at the outboard hinge location. Use a belt sander to trim the outboard hinge as necessary as per the attached drawing. Reinstall the aileron hinges and recheck alignment as per assembly manual task W-12.

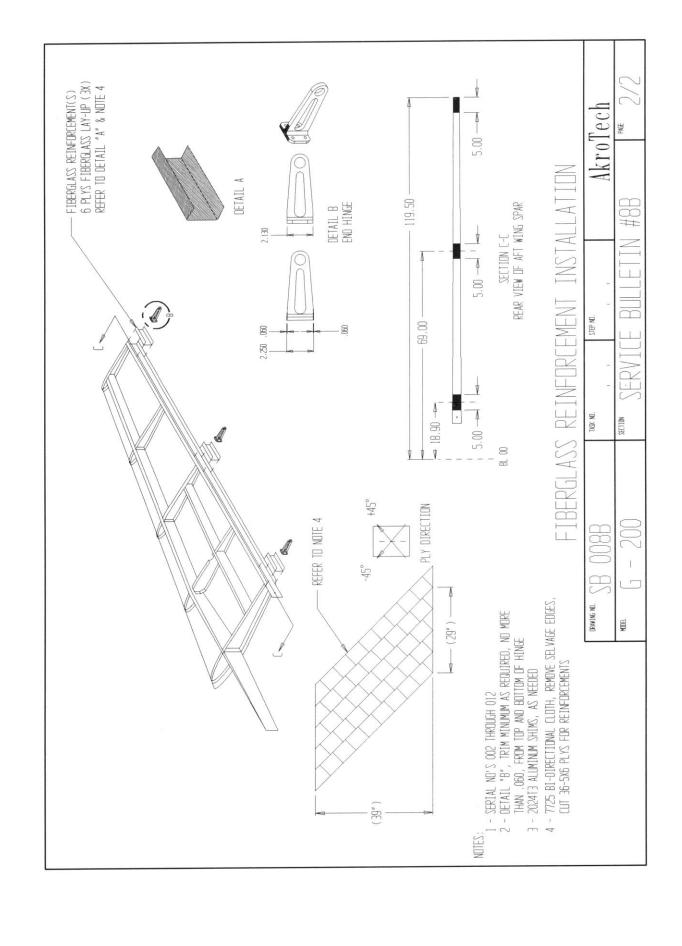
G-200 aircraft with the serial numbers listed above need to have the rear wing spars modified as specified in this service bulletin. Compliance with this service bulletin should be accomplished before further flight. Compliance with this service bulletin can be accomplished before or after the wings have been closed.

Remove aileron hinges from the wings. Prepare the rear spars for bonding at the areas indicated in the attached drawing by cleaning with acetone, sanding thoroughly with 80 grit sandpaper, and recleaning with acetone. Carefully fill the aileron hinge mounting holes with a bright color of modeling clay.

Layup six plies of fiberglass with a ± 45 degree fiber orientation on plastic. This layup should be large enough to make six reinforcements, totaling approximately 24" x 24". Cut out the six reinforcements, approximately 5" x 6"each, from this piece. Paint the prepared areas on the rear spar with laminating resin.

Place a reinforcement on the rear spar at its designated areas, carefully working out all air from under the layup and maintaining the fiber orientation at ± 45 degrees to the spar. Use a fine point pick to push the fibers aside around each aileron hinge mounting hole. Again remove any air from under the layup. Clear tape several paint sticks and use spring clamps to hold the layups against the top and bottom rear spar flanges. This will help hold the lay-ups tight against the rear spar face. Repeat the process for each of the indicated areas. Inspect the reinforcements to assure that they are wrinkle free and there is no air under the layup.

After the layups have cured, trim them flush with the trailing edge of the wing. Clear any remaining fibers from the aileron hinge mounting holes using a 1/4 inch drill bit. Use caution that the drill bit does not go so far into the hole as to damage the nutplate!!

Measure the distance between the rear spar flanges at the outboard hinge location. Use a belt sander to trim the outboard hinge as necessary as per the attached drawing. Reinstall the aileron hinges and recheck alignment as per assembly manual task W-12.

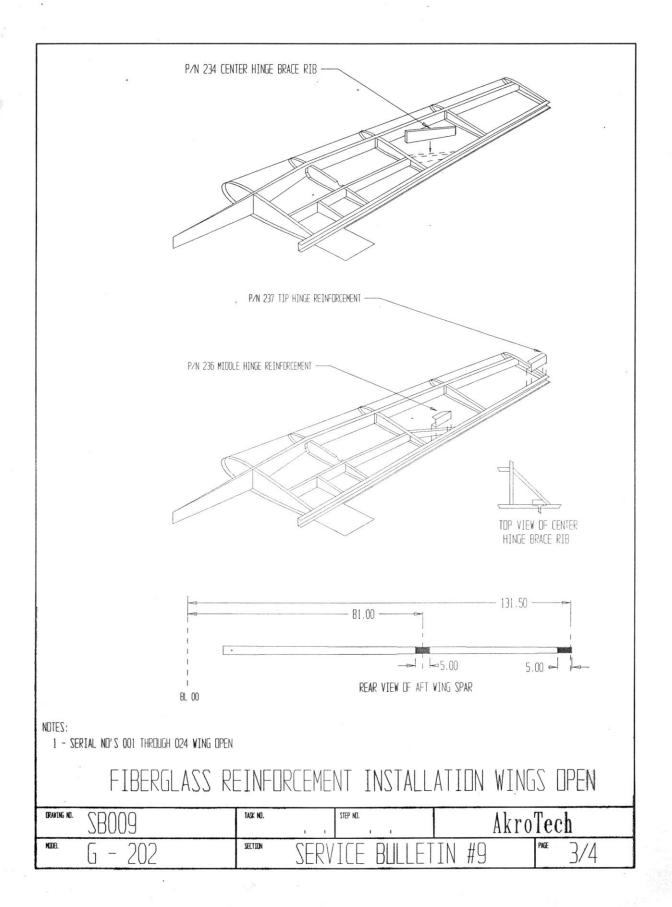
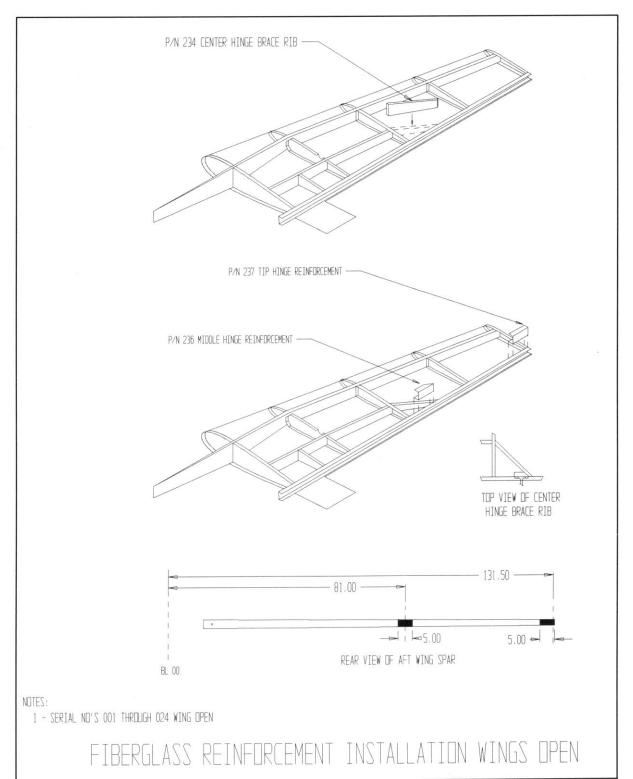
DRAWING NO.	SB009	TASK NO.	STEP NO.	Akro	Tech
MODEL.	G - 202	SECTION SERV	ICE BULLET	IN #9	PAGE 3/4

G-202 aircraft with the serial numbers listed above need to have the rear wing spars reinforced as specified in this service bulletin. Compliance with this service bulletin should be accomplished before further flight.

Mark the location of the reinforcing rib and spar reinforcements on the inside of the wing as shown in the attached drawing. Trim the outboard end of the middle hinge reinforcement at approximately a 45 degree angle so the brace rib will fit properly. This rib is positioned from the rear fuel tank closeout to just outboard of the center hinge. Prepare all of the marked areas for bonding by sanding with 80 grit sandpaper then cleaning with acetone. Bond the inboard and outboard hinge reinforcements and the brace rib in place using Hysol. After cure re-drill the aileron hinge mounting holes and mount the backing plates as per assembly manual task W-13.

Remove aileron hinges from the wings. Prepare the rear spars for bonding at the areas indicated in the attached drawing by cleaning with acetone, sanding thoroughly with 80 grit sandpaper, and recleaning with acetone. Carefully fill the aileron hinge mounting holes with a bright color of modeling clay.

Layup 8 plies of fiberglass with a ± 45 degree fiber orientation on plastic. This layup should be large enough to make 6 reinforcements, totaling approximately 24" x 24". Cut out the six reinforcements, approximately 5" x 6"each, from this piece. Paint the prepared areas on the rear spar with laminating resin.

Place a reinforcement on the rear spar at its designated areas, carefully working out all air from under the layup and maintaining the fiber orientation at ± 45 degrees to the spar. Use a fine point pick to push the fibers aside around each aileron hinge mounting hole. Again remove any air from under the layup. Clear tape several paint sticks and use spring clamps to hold the layups against the top and bottom rear spar flanges. This will help hold the lay-ups tight against the rear spar face. Repeat the process for each of the indicated areas. Inspect the reinforcements to assure that they are wrinkle-free and there is no air under the layup.

Replace center and outboard hinges P/N's 10-001, 10-002 with new hinges P/N's 10-100, 10-101 respectively. Reinstall the aileron hinges and recheck alignment as per assembly manual task W-12.

Mark the upper and lower wing skin surfaces at the center hinge location for skin reinforcements. Prepare the marked areas for bonding by sanding with 80 grit sandpaper and cleaning with acetone. Prepare skin reinforcements P/N 20-238 in a similar manner. Bond upper and lower skin reinforcements in place with Hysol.

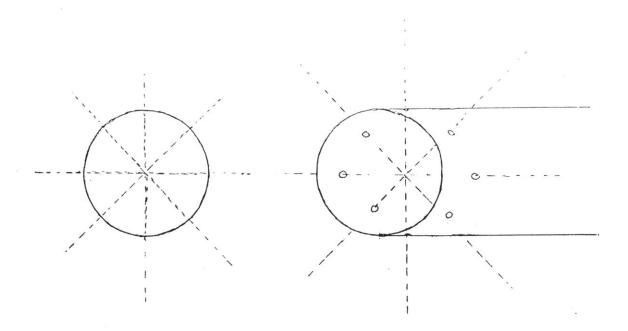
During inspection of G-202 S/N 002, the rear elevator pushtube was found to be worn in the area of the rivets that secure the fittings to the tubing. This allowed the fittings to move relative to the tubing. All Giles aircraft using a 1.5 inch diameter elevator pushtube that has the pushtube end fittings secured with 4 or 6 rivets per fitting need to have the amount of rivets securing the end fittings increased to 8 per fitting.

Make sure there are at least 8 structural rivets securing each pushtube fitting to the pushtube, instead of 4 as originally specified. If the fittings have not been installed, use Hysol to bond the fittings into the tubing (in addition to installing the rivets). See drawing below.

USE 8 CR3242-4-3 RIVETS PER END
